## Cone-beam computed tomography performance and endodontic filling material influence in the diagnosis of horizontal root fracture

**Citation for article:** Rayiat N, Madani ZS, Moudi E, Bijani A. Cone-beam computed tomography performance and endodontic filling material influence in the diagnosis of horizontal root fracture. Caspian J Dent Res 2020; 9:17-22.

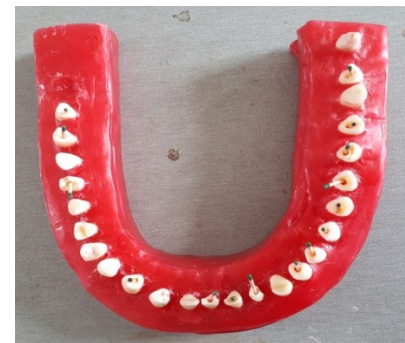
**Fig.2 mounting teeth in the U-shaped wax rim.**

**Horizontal root fracture induction:** To induce the horizontal fracture, the teeth were fixed inside the industrial clamp along the longitudinal axis, and then hit by a hammer in the direction of perpendicular to the longitudinal axis of the tooth (figure 1). The teeth sectioned into more than two slices or chipped at the borders were excluded from the study, and were replaced based on the inclusion criteria. The broken slices were placed together carefully without displacement and fixed with a cyanoacrylate adhesive. In general, the fracture was created randomly in 56 samples from 100 (29 prepared teeth, 27 not prepared). In the prepared group, when adhering two slices, a 4% tapered gutta-percha with appropriate fit and without sealer was placed inside the canal. The specimens were coded by the person who was responsible for inducing the teeth fracture and had no role in the observations, and then mounted randomly in the U-shaped wax rim with a diameter and thickness of 2 cm (figure 2).
