# **Original Article**

# Effect of three veneering techniques on fracture resistance and marginal adaptation of zirconia-based crowns

*Citation for article:* Amiri Daneshvar F, Alhavaz Ah, Ahmadizenouz G, Bijani A. Effect of three veneering techniques on fracture resistance and marginal adaptation of zirconia-based crowns. Caspian J Dent Res 2020; 9: 16-25.

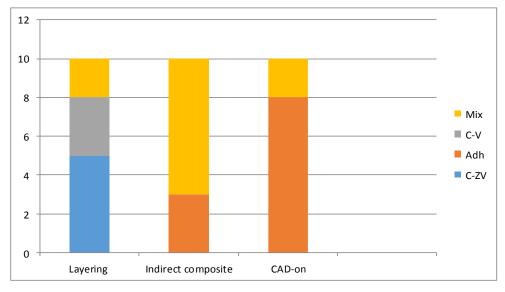
Figure 3. Frequency of failure modes in study groups. Mix: Mix fracture, C-V: cohesive fracture of the veneering layer, Adh: adhesive fracture, C-ZV: cohesive fracture of both veneering layer and zirconia core

Figure 2 illustrates different failure modes of the samples in the study groups. The cohesive failures of zirconia frameworks and veneers were only found in PL group (Fig.3).
