Subcutaneous emphysema as a complication of mandibular third molar extraction: A case report highlighting diagnostic imaging and surgical management strategies

Case Report

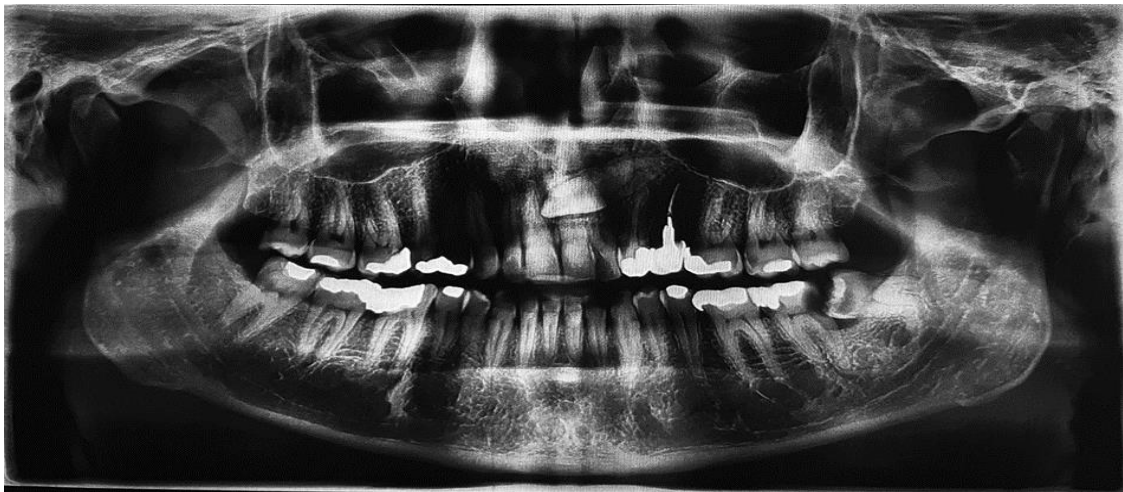
Figure 1. Panoramic image at the first visit

All procedures of this study followed were in accordance with the ethical standards of the responsible committee on human experimentation (institutional and national) and with the Helsinki Declaration of 1975, as revised in 2008. This research project was approved by Mashhad University of Medical Sciences and conducted in the Dental Radiology Center, Mashhad University of Medical Sciences, Mashhad, Iran. The authors would like to express their gratitude to all those who sincerely participated in the study. A 47-year-old male patient was referred to a private dental clinic due to pain and the need for extraction of a wisdom tooth on the left side of the mandible. Following the initial examination, a panoramic image was taken. The image revealed that tooth #38 was in a mesioangular position with occlusal caries, leading to decay in the distal aspect of the second molar (Figure 1).

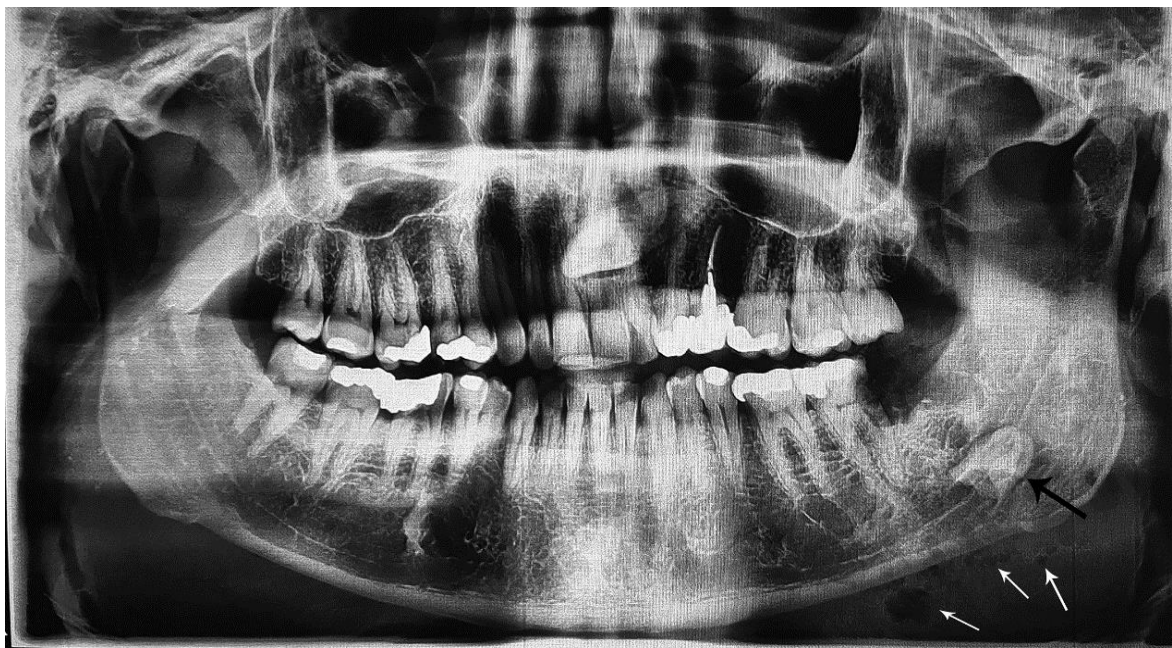
Figure 2. Panoramic image was conducted after the first surgical intervention. Displaced left mandibular third molar root (black arrow), and emphysema were seen (white arrows).

The patient was promptly referred to a dental radiology center for further evaluation. The patient presented with severe pain and tenderness upon palpation, accompanied by swelling on the left side of the face. A panoramic view revealed wisdom tooth root displacement to the submandibular space and subcutaneous emphysema (Figure 2). Then, Cone Beam Computed Tomography (CBCT) was used to examine the status of tooth root displacement. So, the CBCT image confirmed these findings, showing emphysema presence and tooth root displacement (Figure 3A, B).
