Cone-beam computed tomography performance and endodontic filling material influence in the diagnosis of horizontal root fracture

Citation for article: Rayiat N, Madani ZS, Moudi E, Bijani A. Cone-beam computed tomography performance and endodontic filling material influence in the diagnosis of horizontal root fracture. Caspian J Dent Res 2020; 9:17-22.

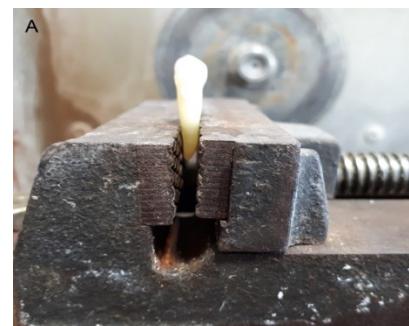
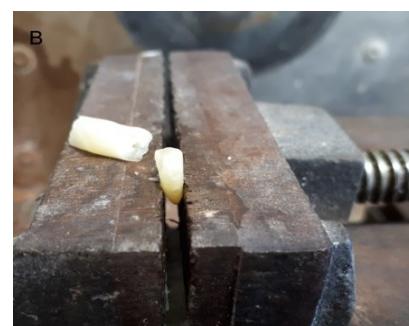
Fig.1 A. The teeth were placed in industrial clamp.
B. Broken tooth horizontally

Horizontal root fracture induction: To induce the horizontal fracture, the teeth were fixed inside the industrial clamp along the longitudinal axis, and then hit by a hammer in the direction of perpendicular to the longitudinal axis of the tooth (figure 1). The teeth sectioned into more than two slices or chipped at the borders were excluded from the study, and were replaced based on the inclusion criteria. The broken slices were placed together carefully without displacement and fixed with a cyanoacrylate adhesive. In general, the fracture was created randomly in 56 samples from 100 (29 prepared teeth, 27 not prepared). In the prepared group, when adhering two slices, a 4% tapered gutta-percha with appropriate fit and without sealer was placed inside the canal. The specimens were coded by the person who was responsible for inducing the teeth fracture and had no role in the observations, and then mounted randomly in the U-shaped wax rim with a diameter and thickness of 2 cm (figure 2).

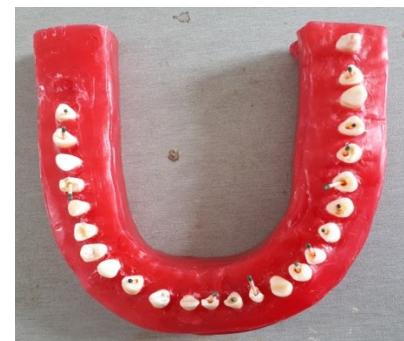
Fig.2 mounting teeth in the U-shaped wax rim.
